TruView Inspections (HI7112)

Condo Unit Inspection

Undisclosed Address

Inspected on Fri, Feb 2 2018 at 2:00 PM

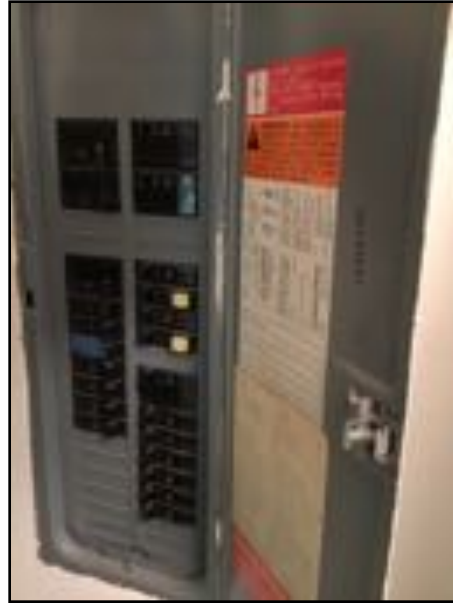
Figure 1-2

Comment 1:
Electrical panel.

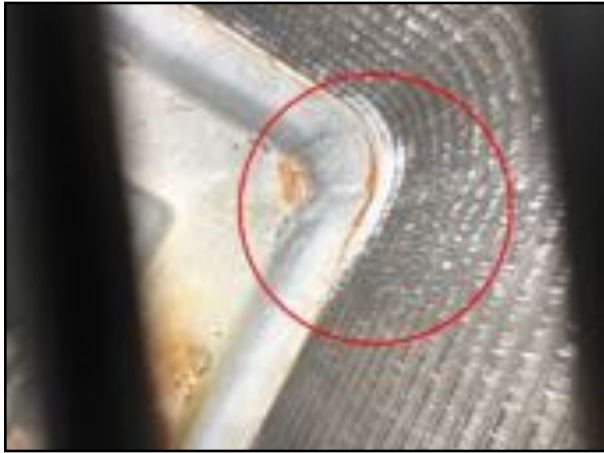
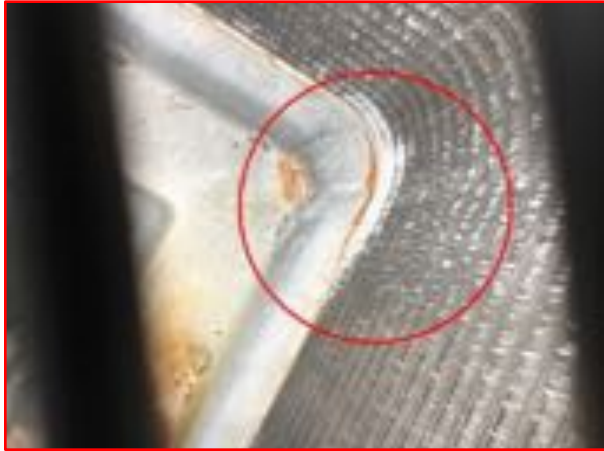
Figure 2-1

Condenser coils are damaged and deteriorated. Replacement is recommended. Estimated cost is \$2,500.

1) Condenser coils are damaged and deteriorated. Replacement is recommended. Estimated cost is \$2,500.

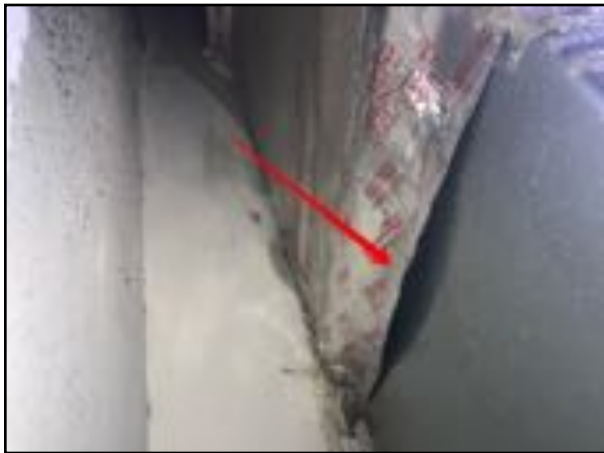
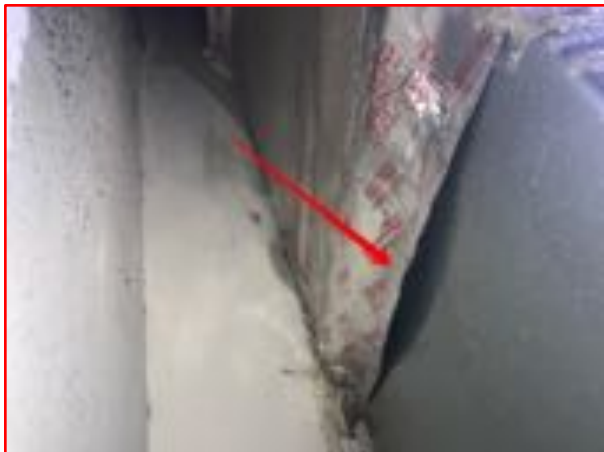
Figure 3-1

Main air duct is not properly sealed. Estimated cost is \$300.

2) Main air duct is not properly sealed. Estimated cost is \$300.

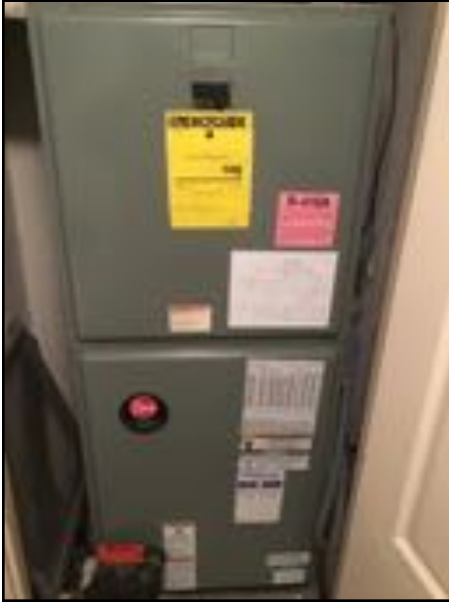
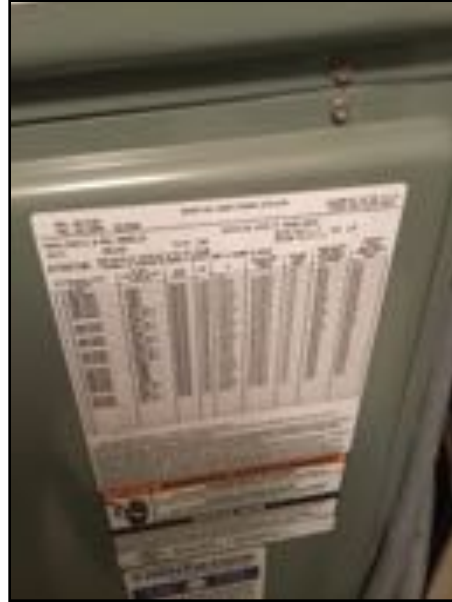
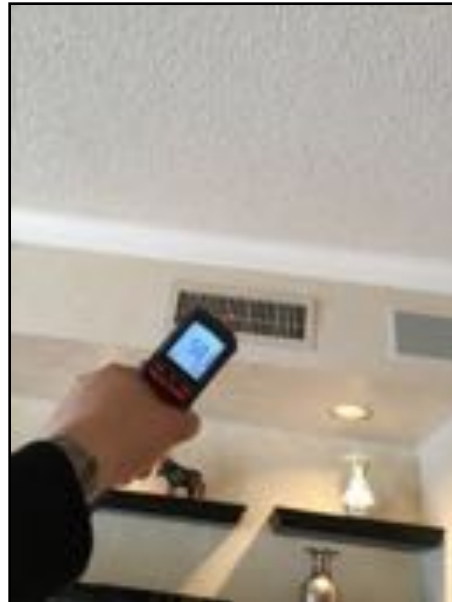
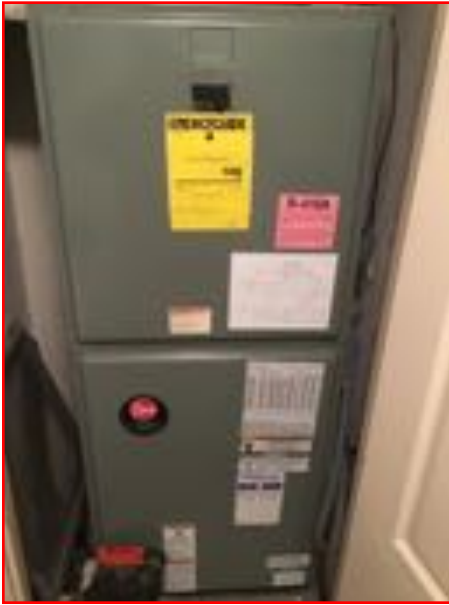
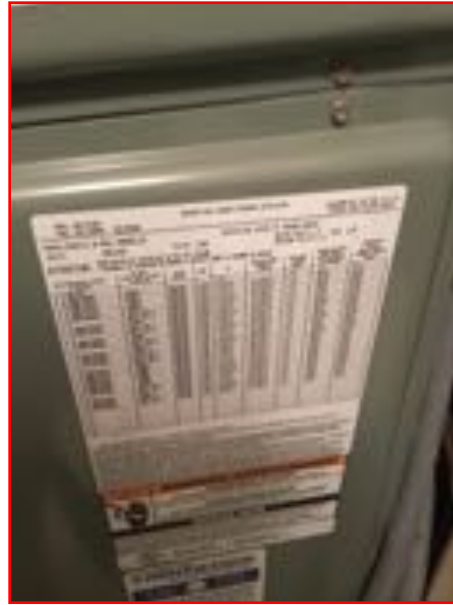
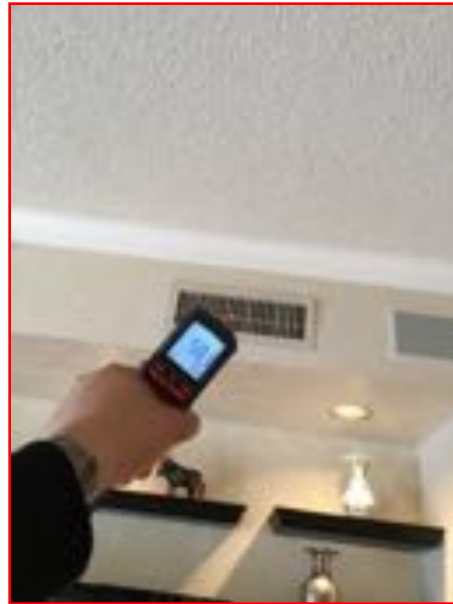
Air conditioning needs to be serviced and coil needs to be cleaned. Estimated cost is \$300.

3) Air conditioning needs to be serviced and coil needs to be cleaned. Estimated cost is \$300.

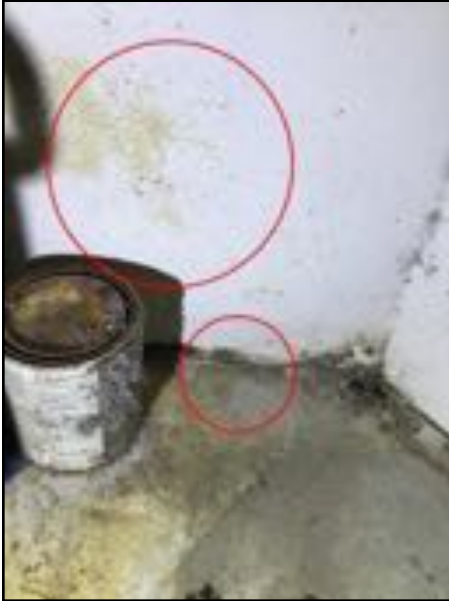
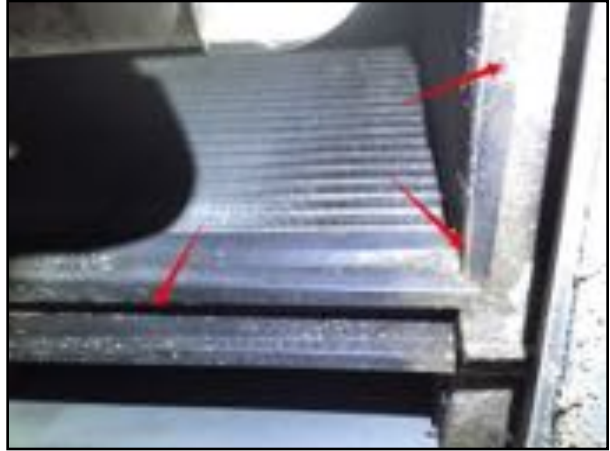
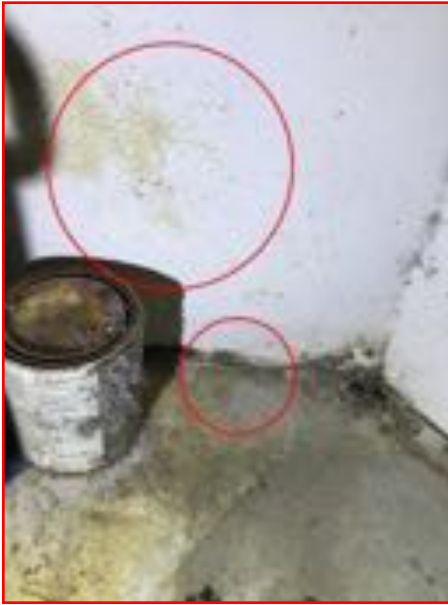
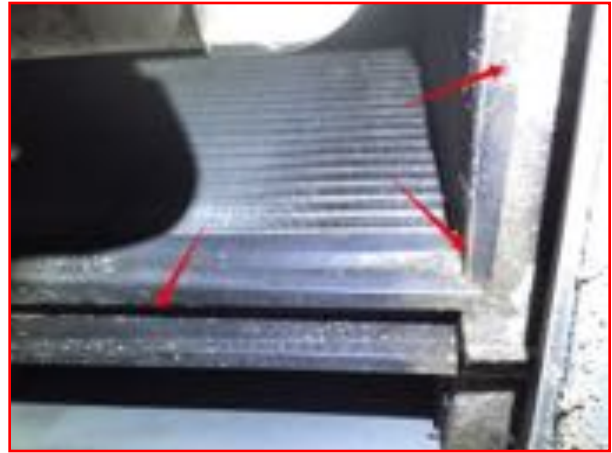
Apparent mold observed on air handler coils and on drywall inside air handler closet. It is recommended that a mold inspection and an indoor air quality test be performed for further evaluation.

4) Apparent mold observed on air handler coils and on drywall inside air handler closet. It is recommended that a mold inspection and an indoor air quality test be performed for further evaluation.

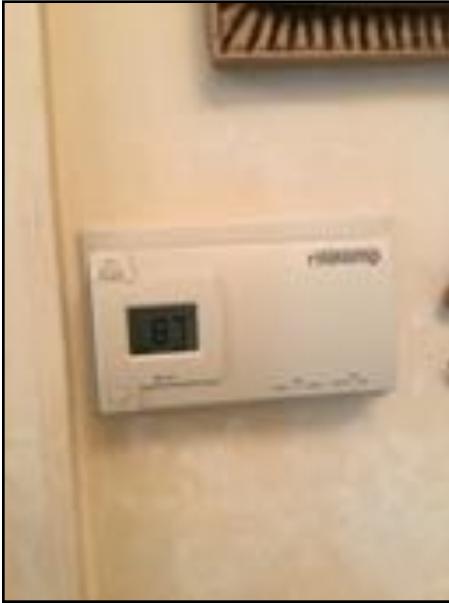
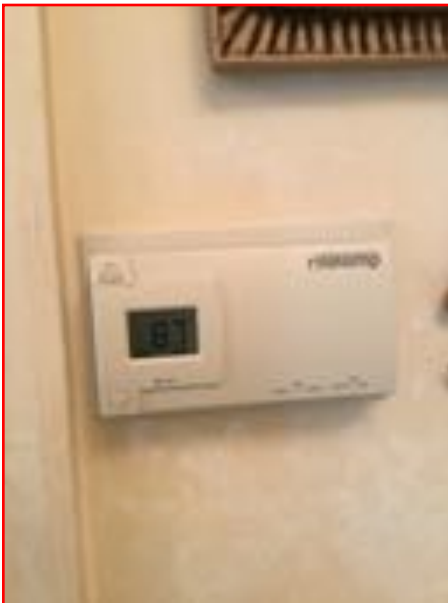
Figure 6-1

**Comment 6:**
Air conditioning system does not have a heater. Estimated cost is \$500.

5) Air conditioning system does not have a heater. Estimated cost is \$500.

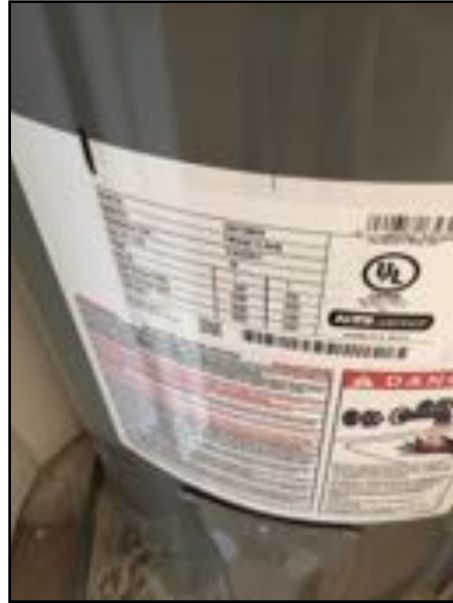
Figure 7-2

Comment 7:
Water heater.

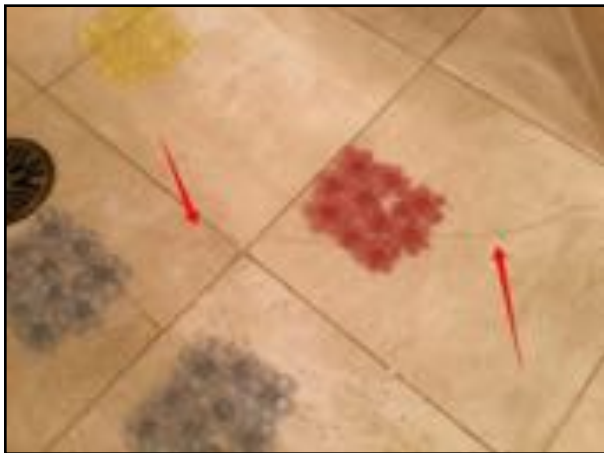
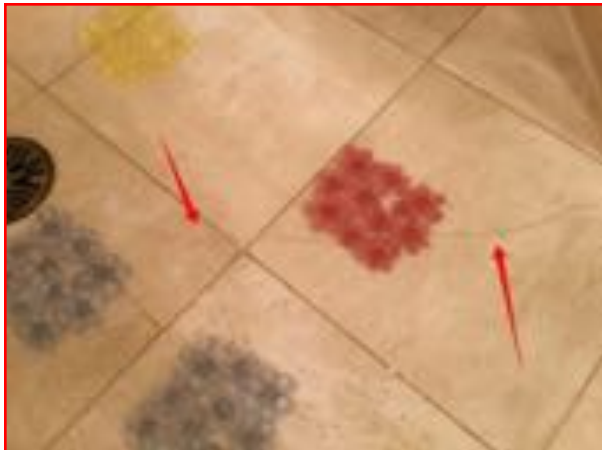
Figure 10-1

Comment 10:
Shower floors are cracked. Estimated cost is \$500.

7) Shower floors are cracked. Estimated cost is \$500.

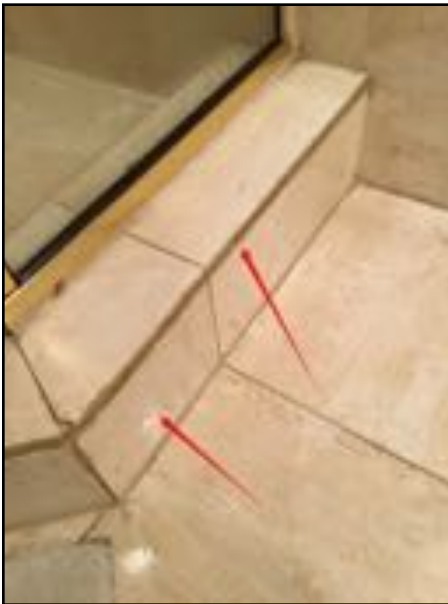
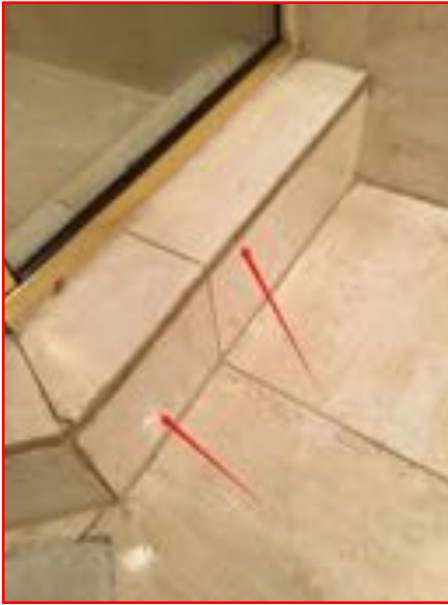
Figure 11-1

Observed loose tiles by shower. Estimated cost is \$300.

8) Observed loose tiles by shower. Estimated cost is \$300.

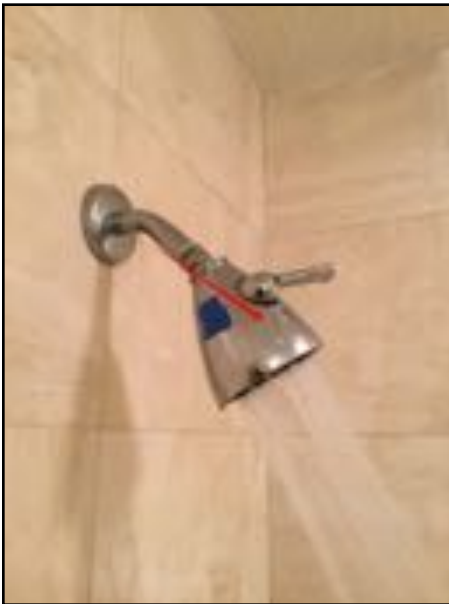
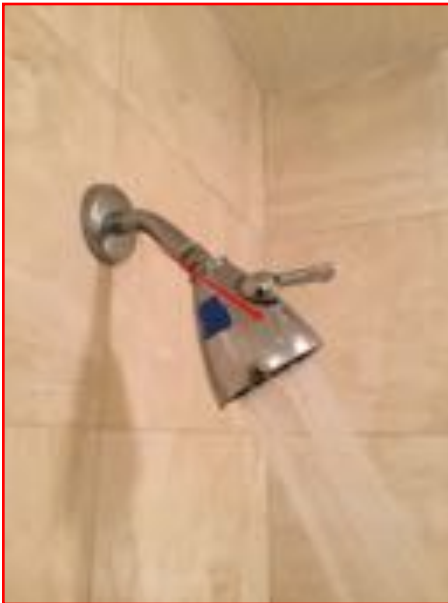
Figure 13-1

Comment 13:
Shower head is leaking. Estimated cost is \$100.

9) Shower head is leaking. Estimated cost is \$100.

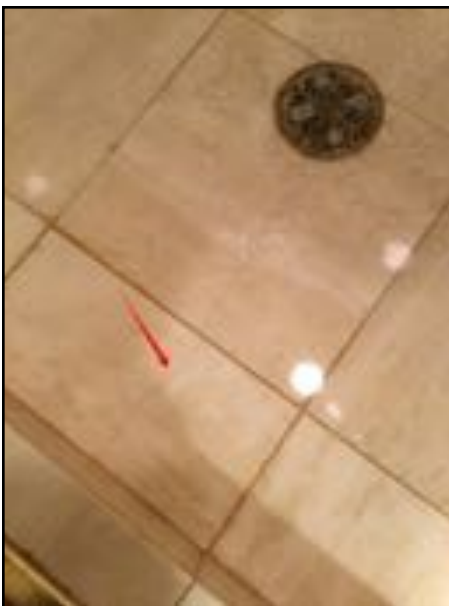
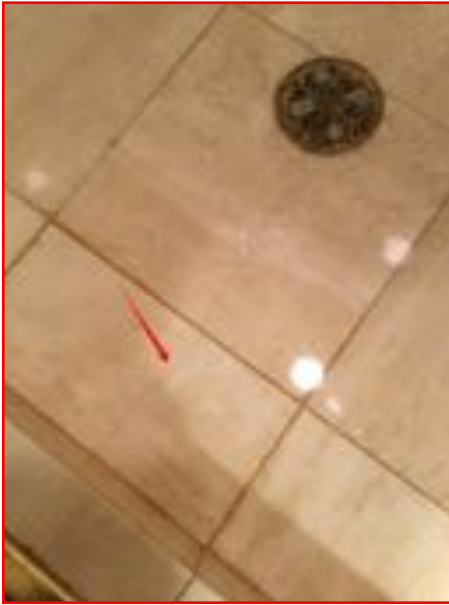
Figure 14-1

Comment 14:
Shower floors are cracked. Estimated cost is \$500.

10) Shower floors are cracked. Estimated cost is \$500.

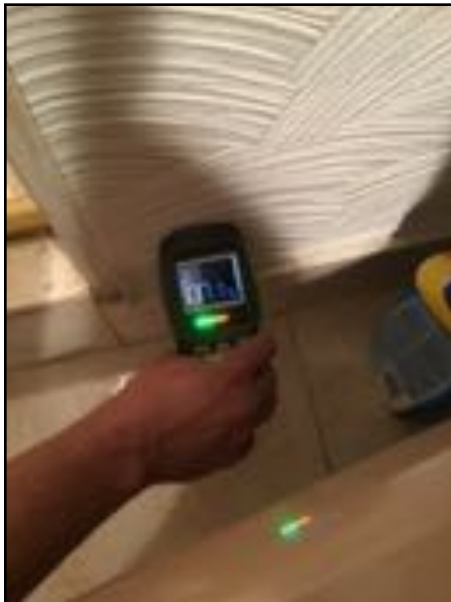
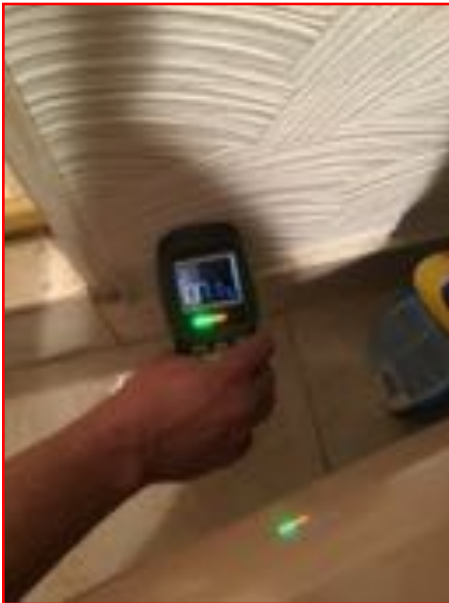
Figure 15-1

71% moisture levels observed by shower walls. It is recommended that an indoor air quality test be performed for further evaluation.

11) 71% moisture levels observed by shower walls. It is recommended that an indoor air quality test be performed for further evaluation.

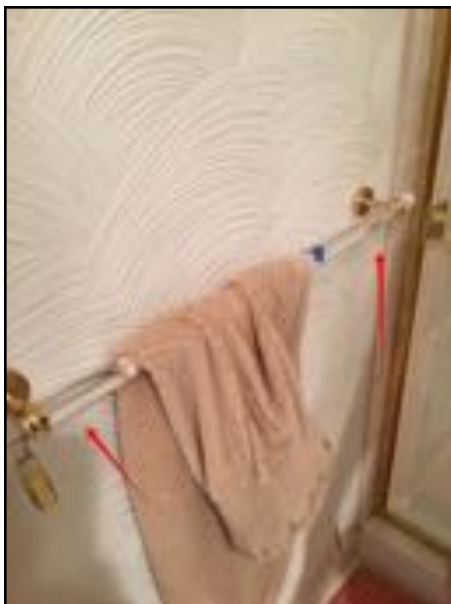
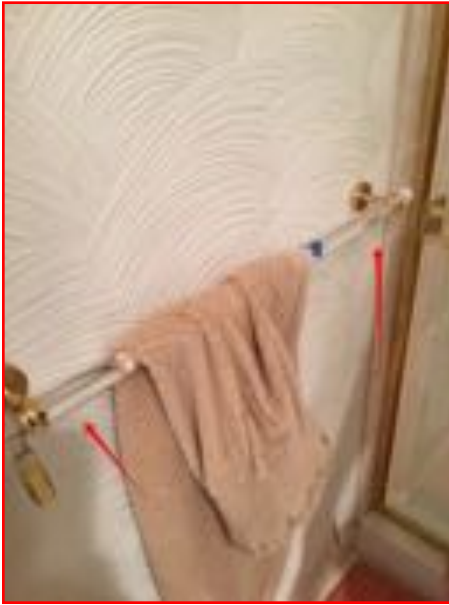
Figure 16-1

Towel holder is loose. Estimated cost is \$100.

12) Towel holder is loose. Estimated cost is \$100.

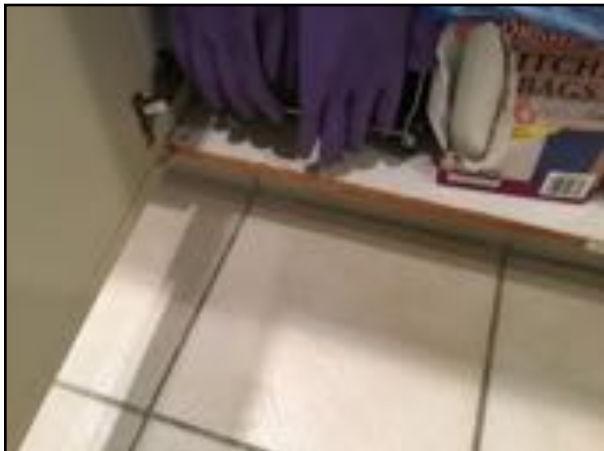
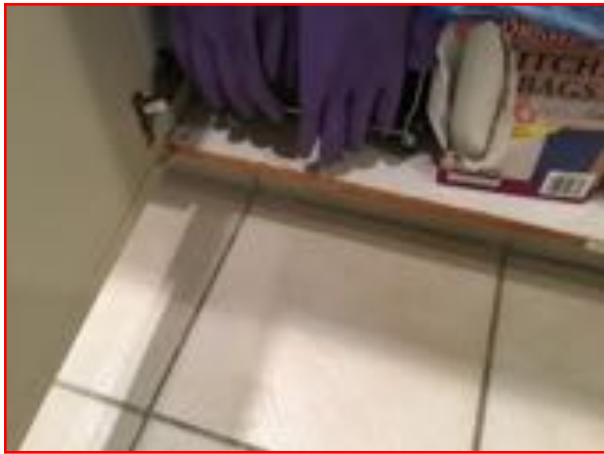
Figure 18-1

Comment 18:
Cabinets have visible damage.

13) Cabinets have visible damage.

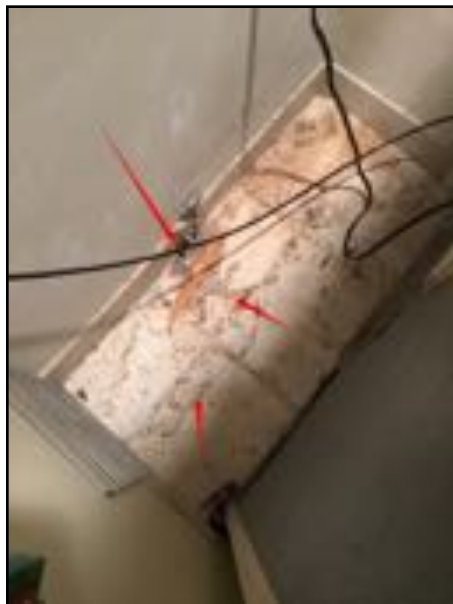
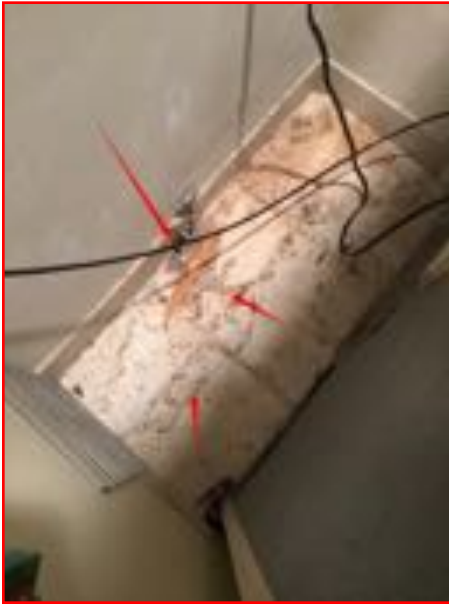
Figure 19-1

Comment 19:
Apparent mold growth observed on floors behind refrigerator. It is recommended that a mold inspection be performed for further evaluation.

14) Apparent mold growth observed on floors behind refrigerator. It is recommended that a mold inspection be performed for further evaluation.

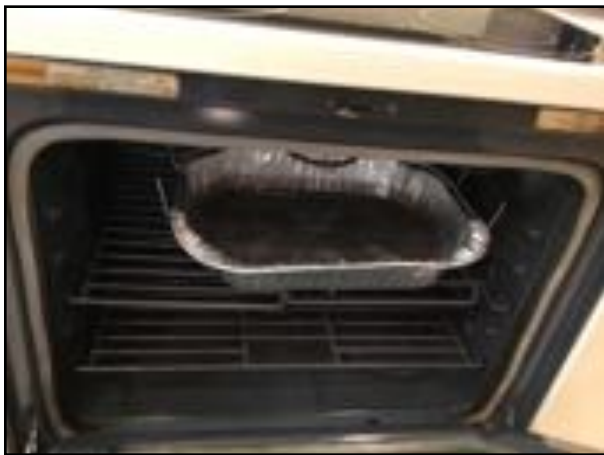
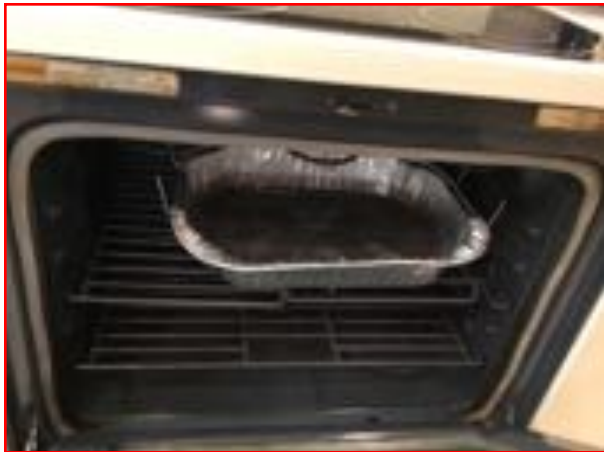
Figure 21-1

Oven light is not functional. Estimated cost is \$50.

15) Oven light is not functional. Estimated cost is \$50.

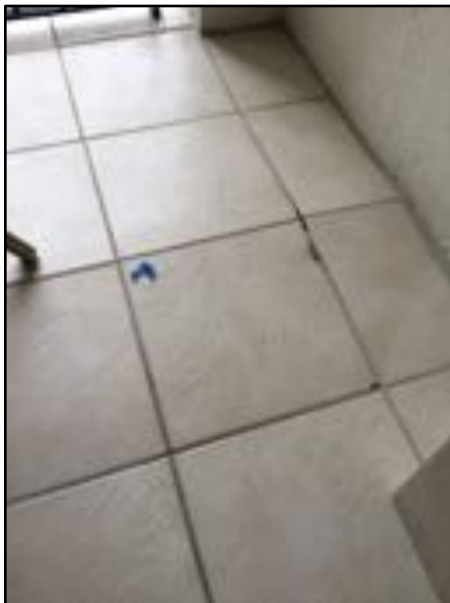
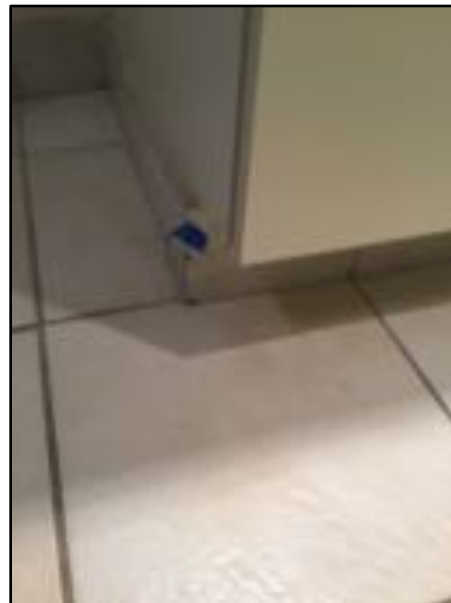
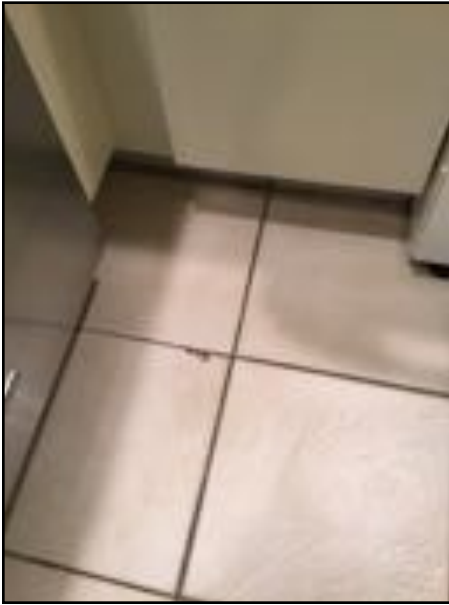
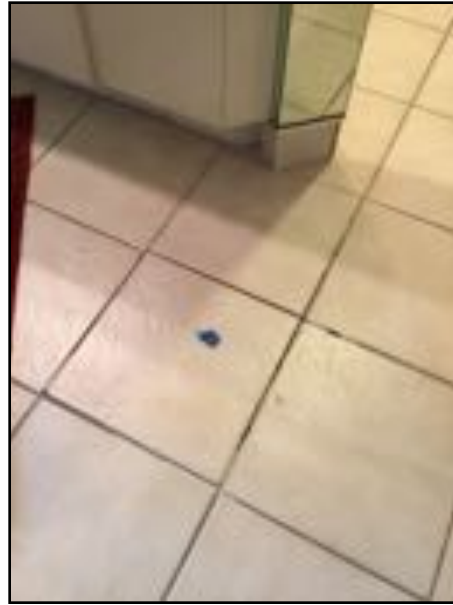
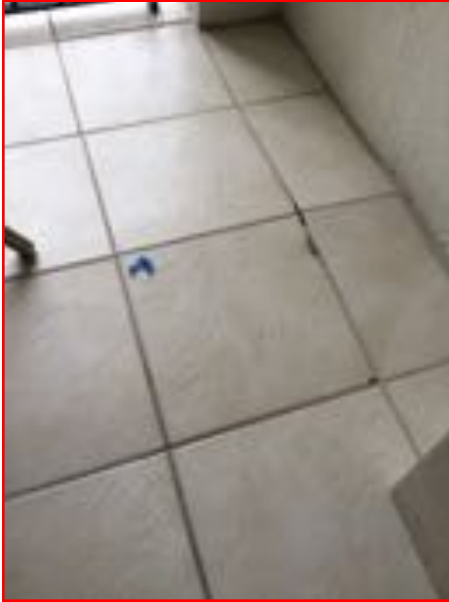
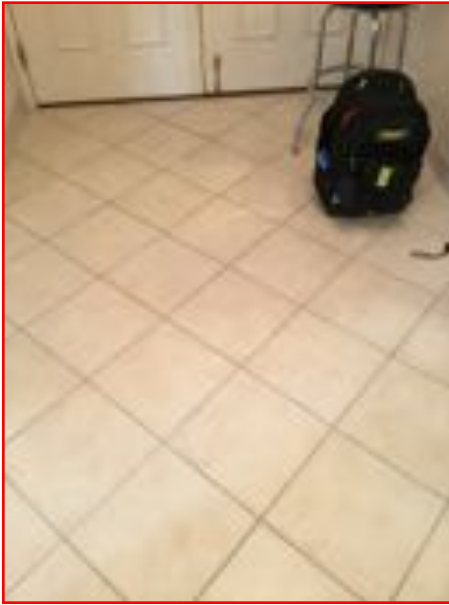
Tile floors inside the unit are loose and there are broken tiles. Replacement is recommended. Estimated cost is \$3,000.

16) Tile floors inside the unit are loose and there are broken tiles. Replacement is recommended. Estimated cost is \$3,000.

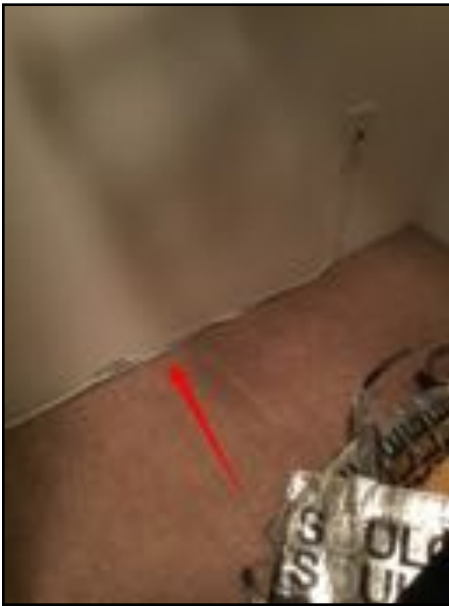
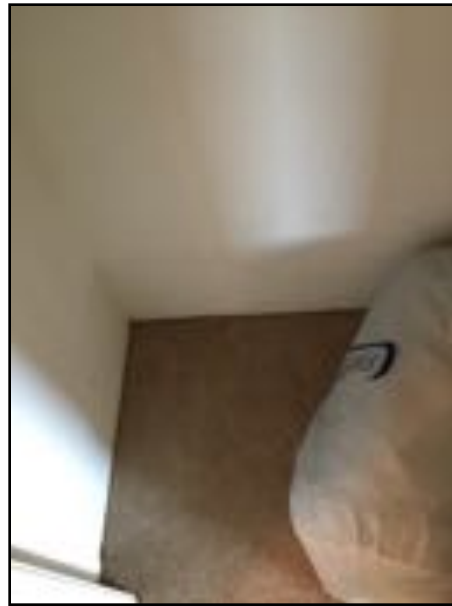
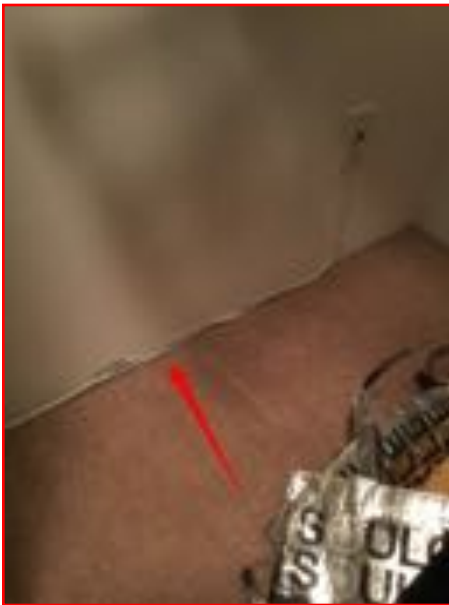
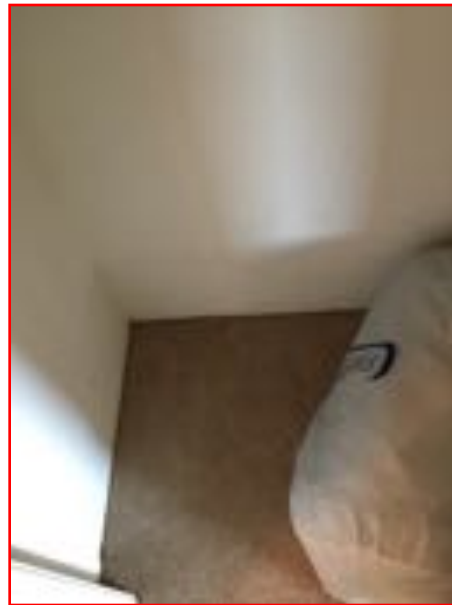
Missing baseboards observed inside bedroom closets. Estimated cost is \$200.

17) Missing baseboards observed inside bedroom closets. Estimated cost is \$200.

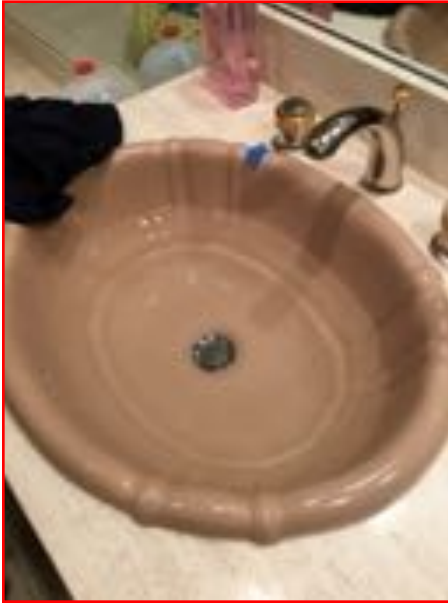
Figure 9-1

Comment 9:
Sinks do not drain properly. Estimated cost is \$100.

6) Sinks do not drain properly. Estimated cost is \$100.
