TRUVIEW INSPECTIONS

FULL HOME INSPECTION

1234 Main St. Miami Florida 33183

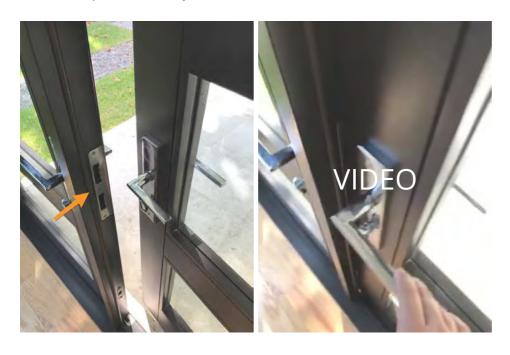
Door latch and/or strike plate is out of alignment. Recommend a handyman repair.

Contact a qualified handyman.

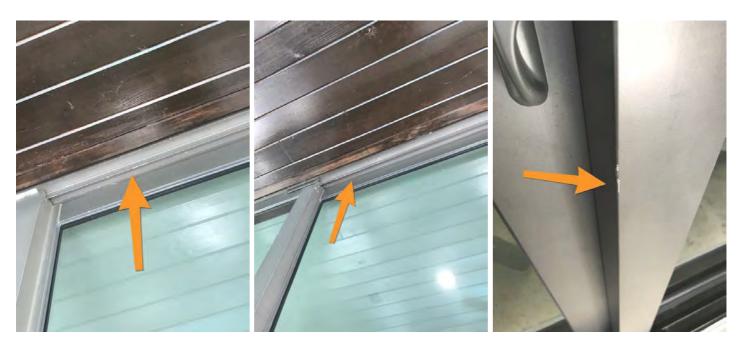
3.1.2 Exterior Doors

DAMAGED EXTERIOR DOORS

Scratches, excess paint, dents, etc observed on exterior doors.

Contact a qualified professional.

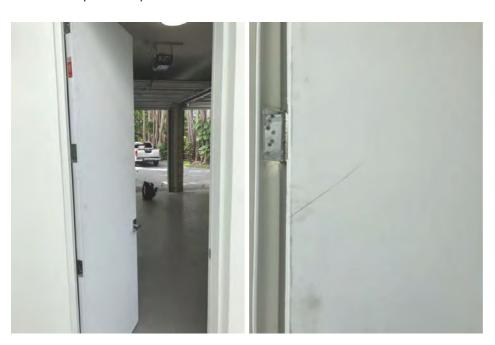
3.1.3 Exterior Doors

NOT PAINTED

Contact a qualified painter.

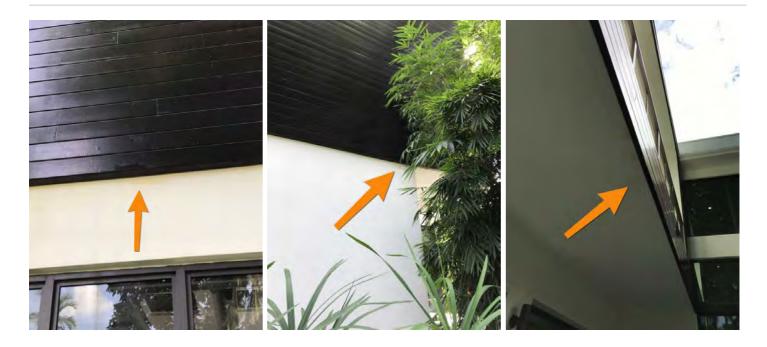
3.2.6 Siding, Flashing & Trim

DAMAGED WOOD SIDING

Damaged board observed.

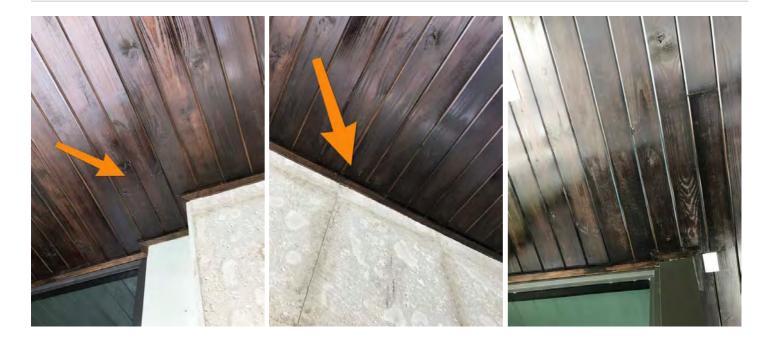
3.4.3 Decks, Balconies, Porches & Steps

MISISNG PAINT

Terrace ceiling has sections where paint/stain is missing or uneven.

Contact a qualified professional.

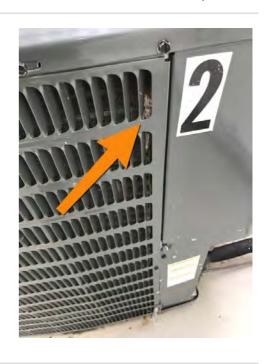
Condenser coils have visible damage/deterioration; evaluation recommended.

Contact a qualified heating and cooling contractor

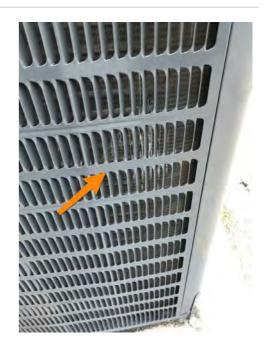
Condenser coils have visible damage/deterioration; evaluation recommended.

Contact a qualified heating and cooling contractor

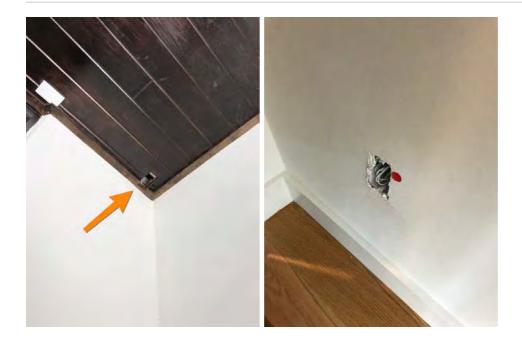
COVER PLATES MISSING

One or more receptacles are missing a cover plate. This causes short and shock risk. Recommend installation of plates.

Contact a handyman or DIY project

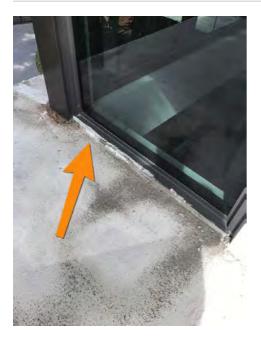
11.3.1 Floors

PAINT STAINS

Paint stains observed on flooring.

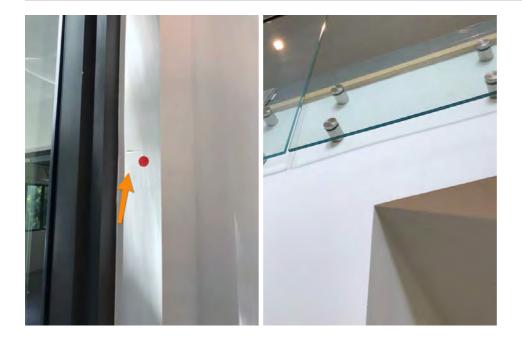
11.5.1 Ceilings

MINOR DAMAGE

Minor damage or deterioration to the ceiling was visible at the time of the inspection.

Contact a qualified handyman.

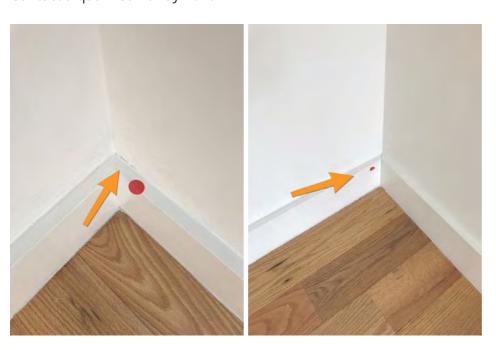
IMPROPERLY CAULKED

Observed baseboards that were not caulked correctly and missing caulk.

Contact a qualified handyman.

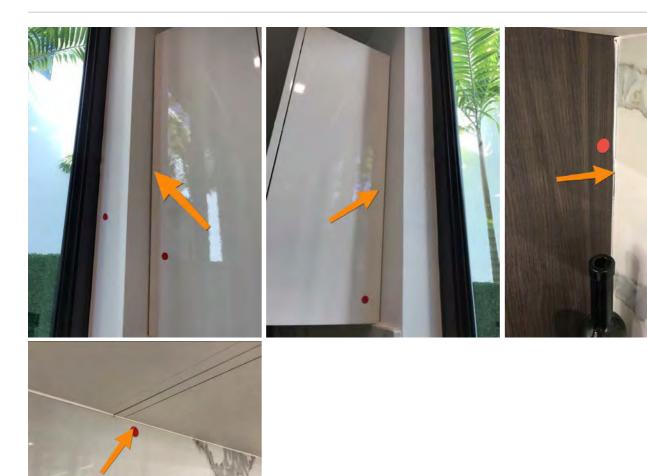
POOR/MISSING CAULK

Kitchen cabinets/countertops was missing sufficient caulk/sealant at the wall. This can lead to water damage. Recommend adding sealant at sides and corners where counters touch walls.

Contact a qualified cabinet contractor.

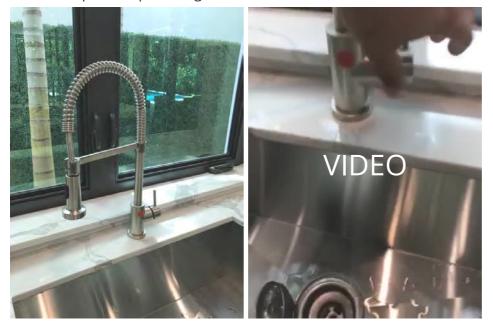
LOOSE FAUCETS

Observed kitchen sink faucets are loose. Repairs are recommended.

Contact a qualified plumbing contractor.

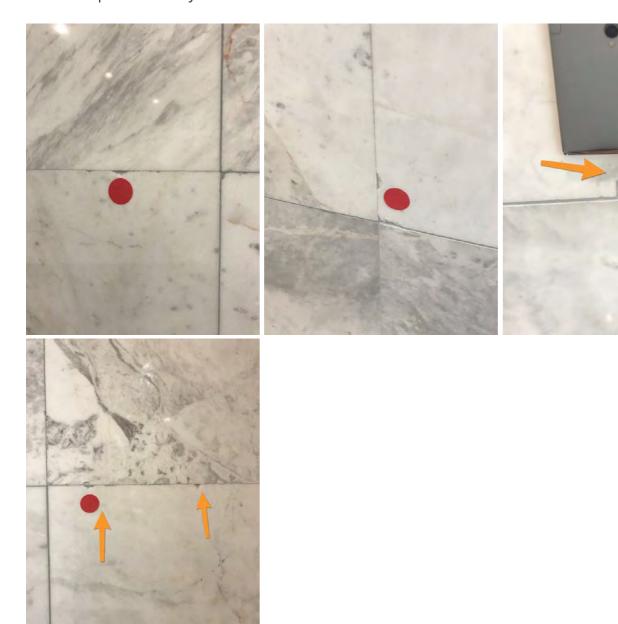
Shower has one or more chipped stones. Recommend a bathroom contractor or handyman repair or replace.

Contact a qualified handyman.
