TruView Inspections (HI7112)

Condo Unit Inspection

Undisclosed Address

Inspected on Fri, Feb 2 2018 at 2:00 PM

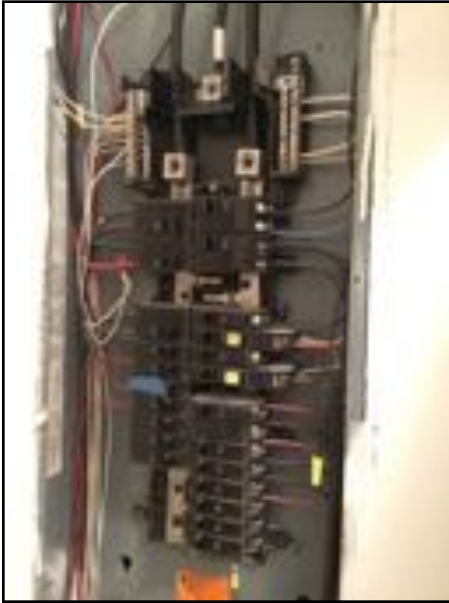
Figure 1-1

Comment 1:
Electrical panel.

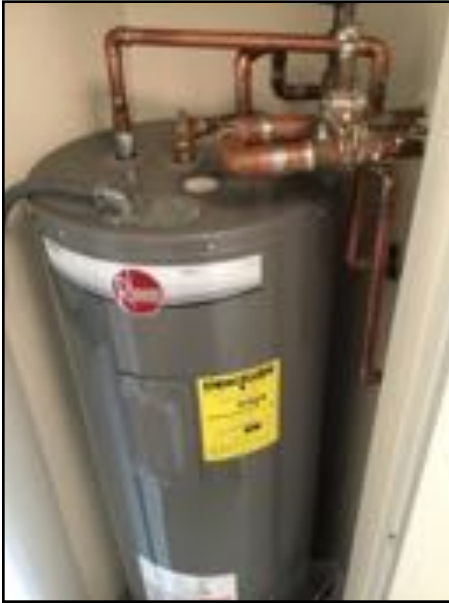
Figure 7-1

Comment 7:
Water heater.

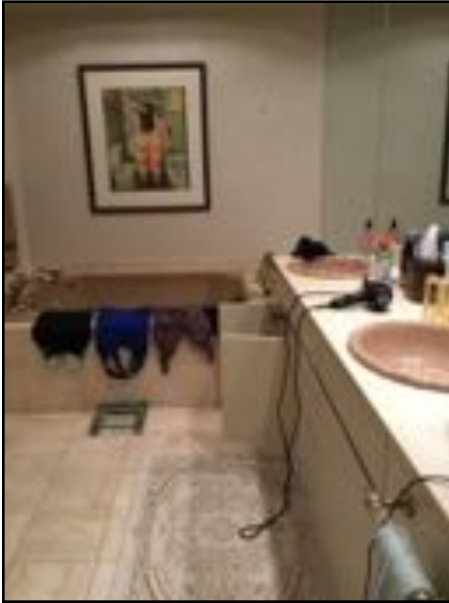
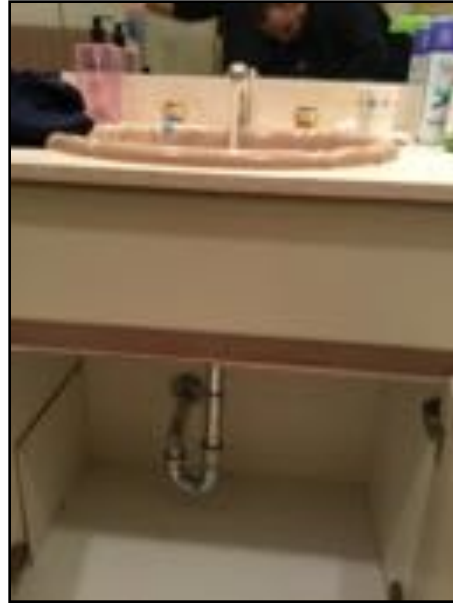
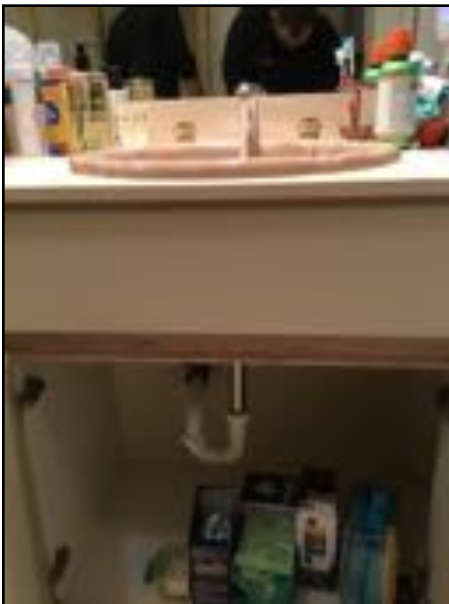
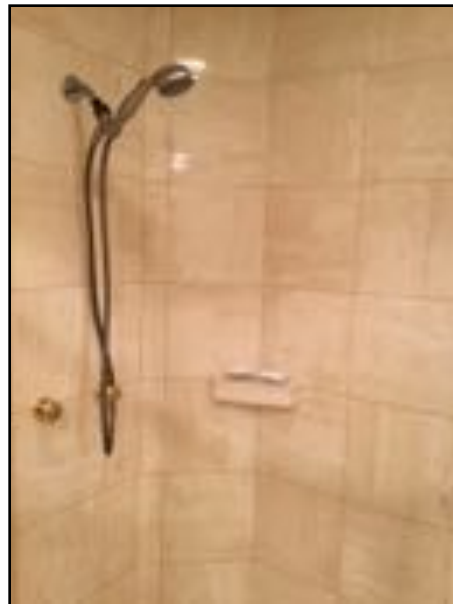
Comment 8:
Bathroom 1.

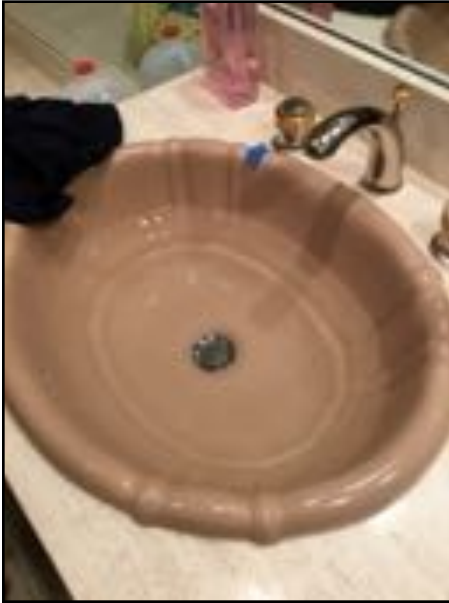
Figure 9-1

Comment 9:
Sinks do not drain properly. Estimated cost is \$100.

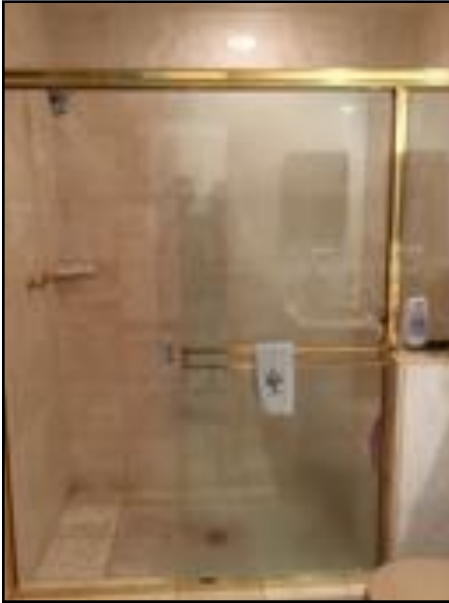
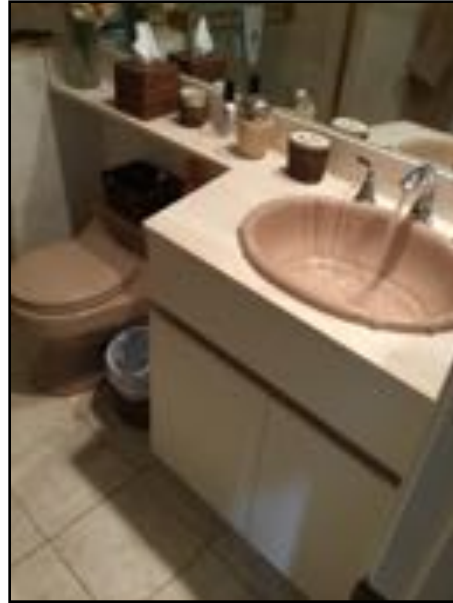
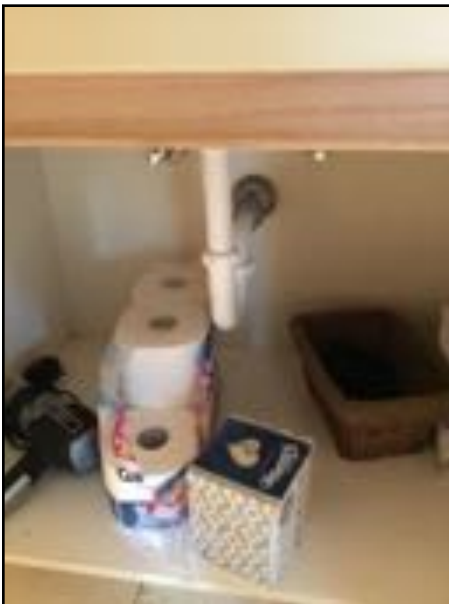
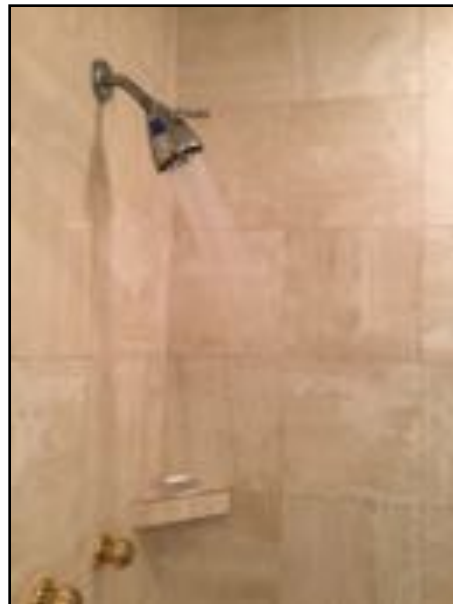
Comment 12:
Bathroom 2.

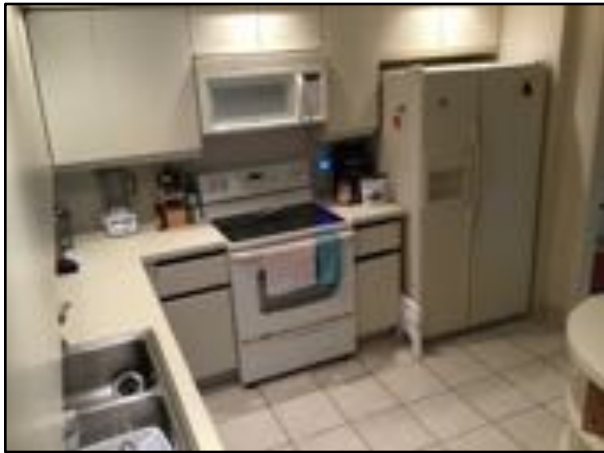
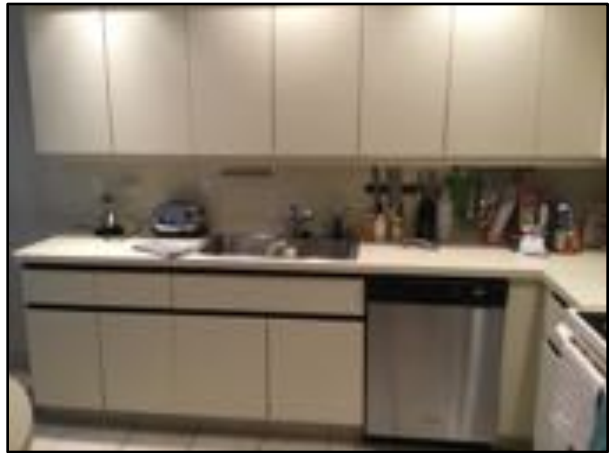
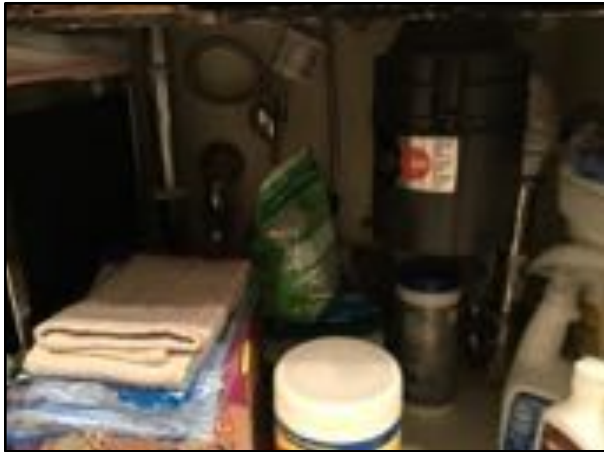
Comment 17:
Kitchen.

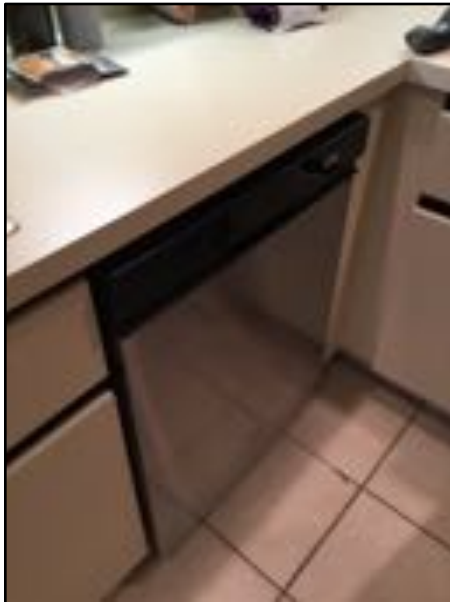
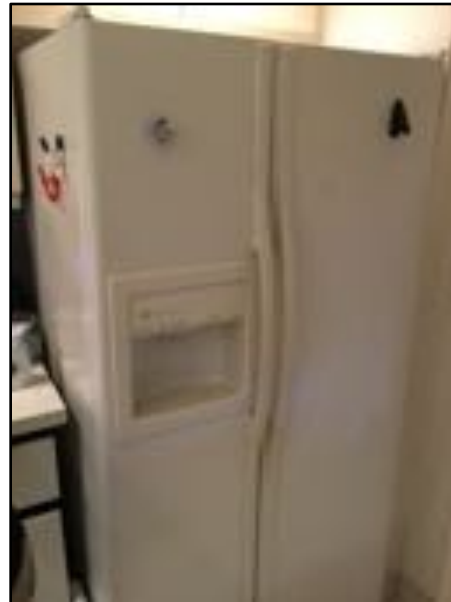
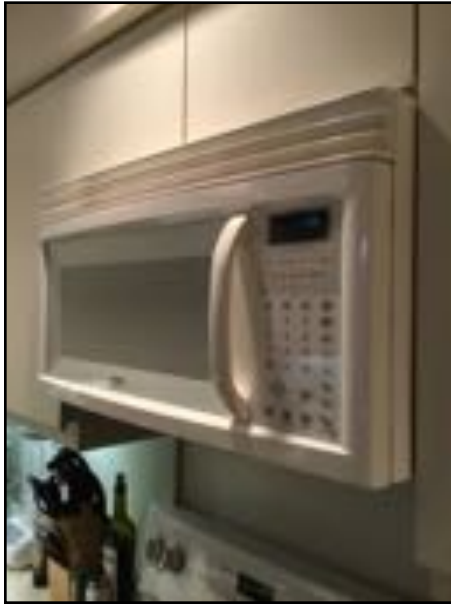
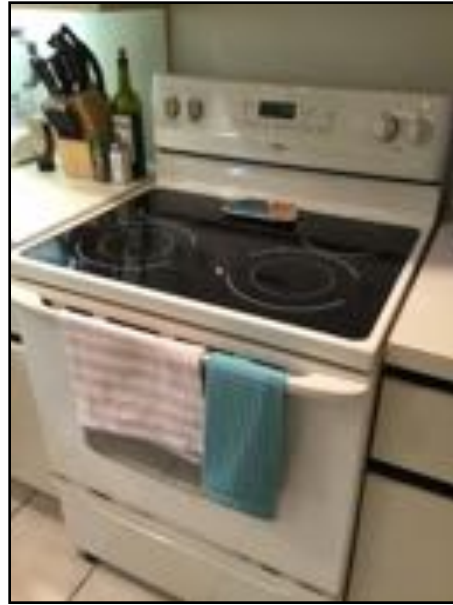
Comment 20:
Appliances.

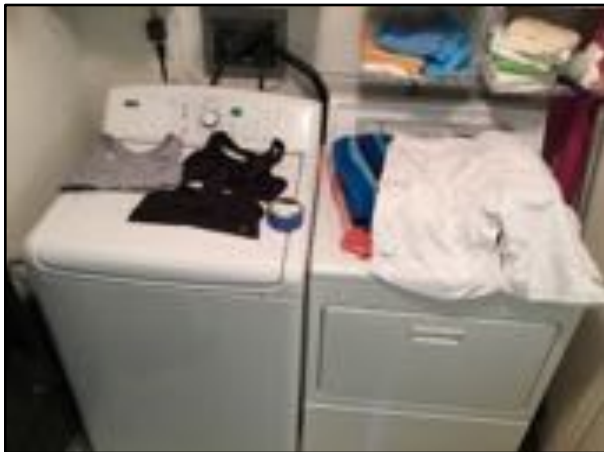
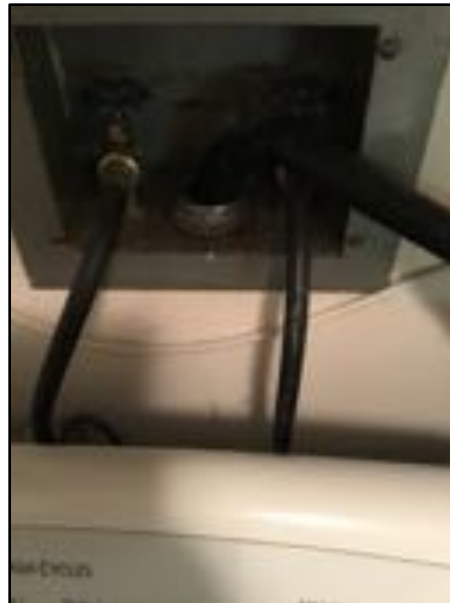
Comment 22:
Laundry room.

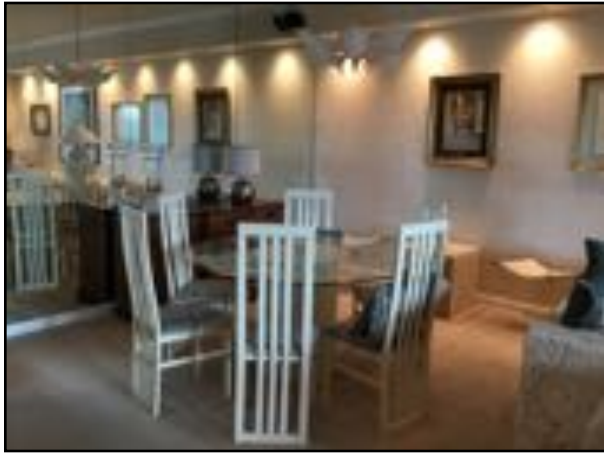
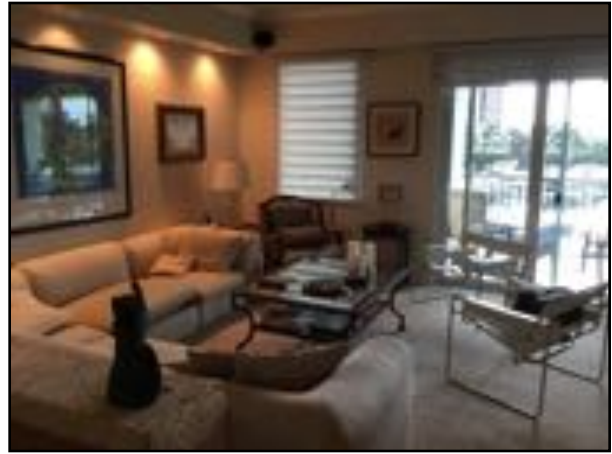
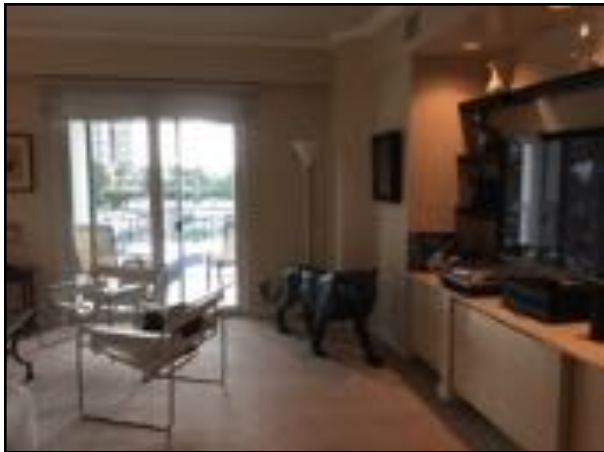
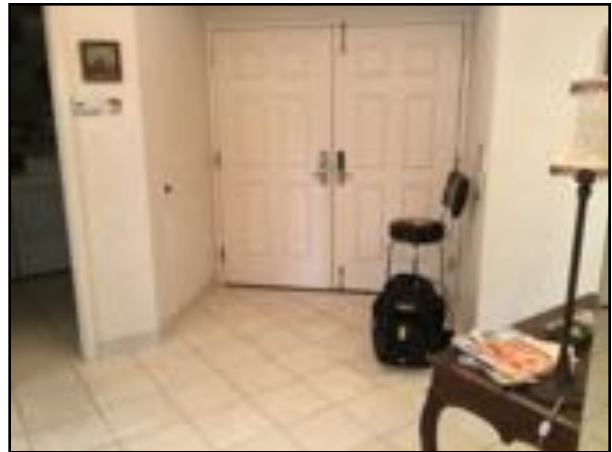
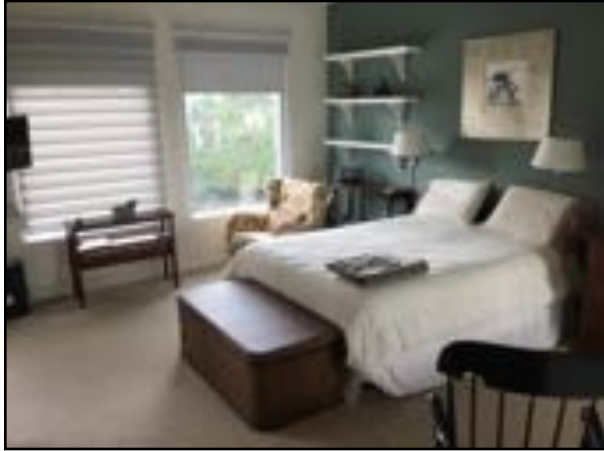
Comment 24:
Interior photos.
